Mineralization on the Evelyn Gold Property, Sonora , Mexico In Context of Local and Regional Structures

By Dr. Jonathan Nourse

September 18, 2017

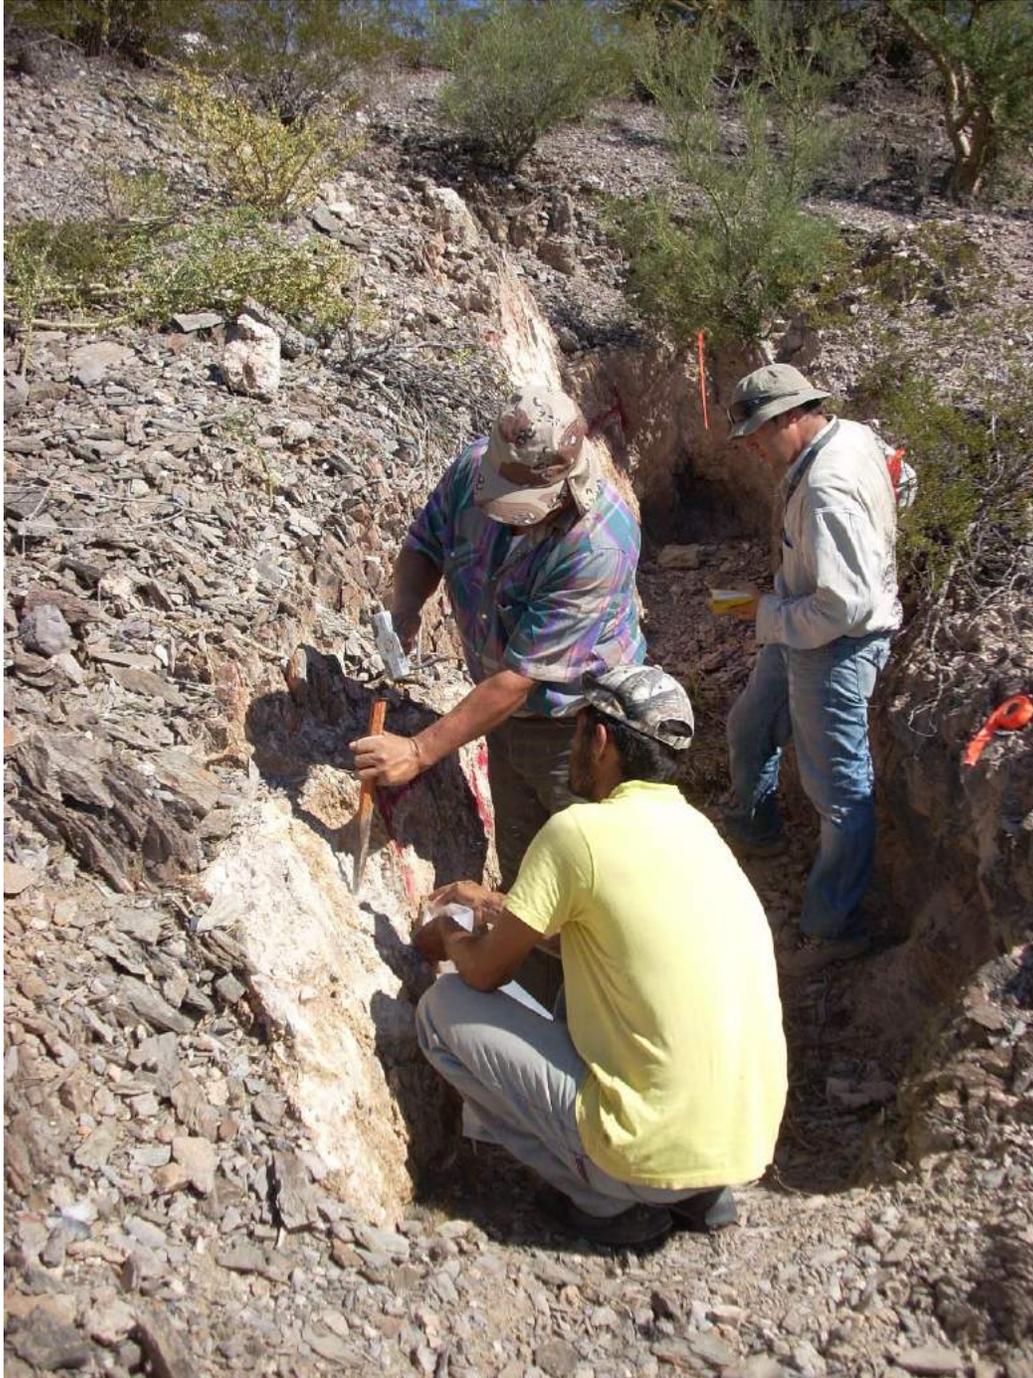
Several significant mine workings (>5 m deep) exploit a shear zone and associated quartz vein system that is well exposed for about 200 m along the north end of the southeastern ridge. This structure yielded the highest gold assays on the Evelyn Property—we collected nine chip samples that ran between 1.2 and 26 ppm Au. **Photo 1** shows a typical trench exposure located just north of the saddle where the last adit occurs.

Photo 1. View northeast of trench along Mine Workings Shear Zone at Waypoints 206-207. Rock-chip samples ELZB 40-42 collected here ran 26.1 ppm, 8.8 ppm, and 19.3 ppm Au, respectively.

The high grade vein system exposed by old mine workings in the southeastern ridge presents an obvious drill target that is attractive for a number of reasons. Rock chip assays collected from this structure yielded the highest gold assays recovered on the Evelyn Property. Orientations of the veins and host sandstone unit are very consistent, providing straightforward down-dip projections for a drill program. A couple of simple cross sections, field checked for feasible drill pad location, should facilitate definition of likely drill intercepts. The scale of the existing excavations suggests that significant gold has been recovered. The down side is the relatively narrow width of this shear zone along its 200 m exposed strike length; typically the hematite-silica mineralized rock encompassing the vein network measures only 2-3 meters true structural thickness. The key question is whether this mineralized zone pinches out or broadens with depth. That question can only be answered with a relatively expensive drill program.

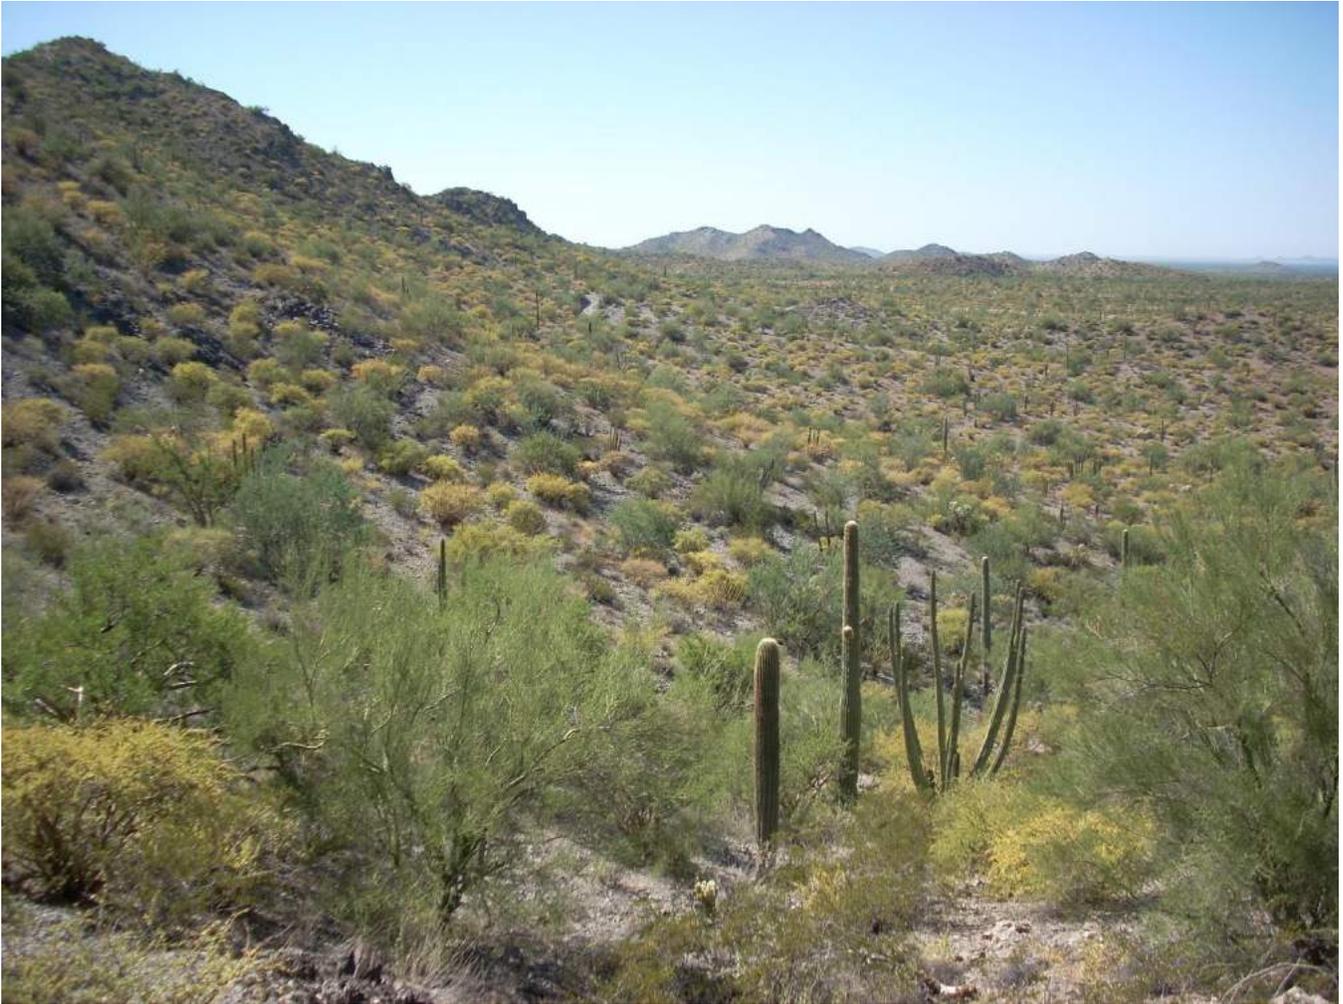
Photo 2. View southwest from saddle along projection of Mine Workings Shear Zone that is covered by colluvium along the base of the ridge.

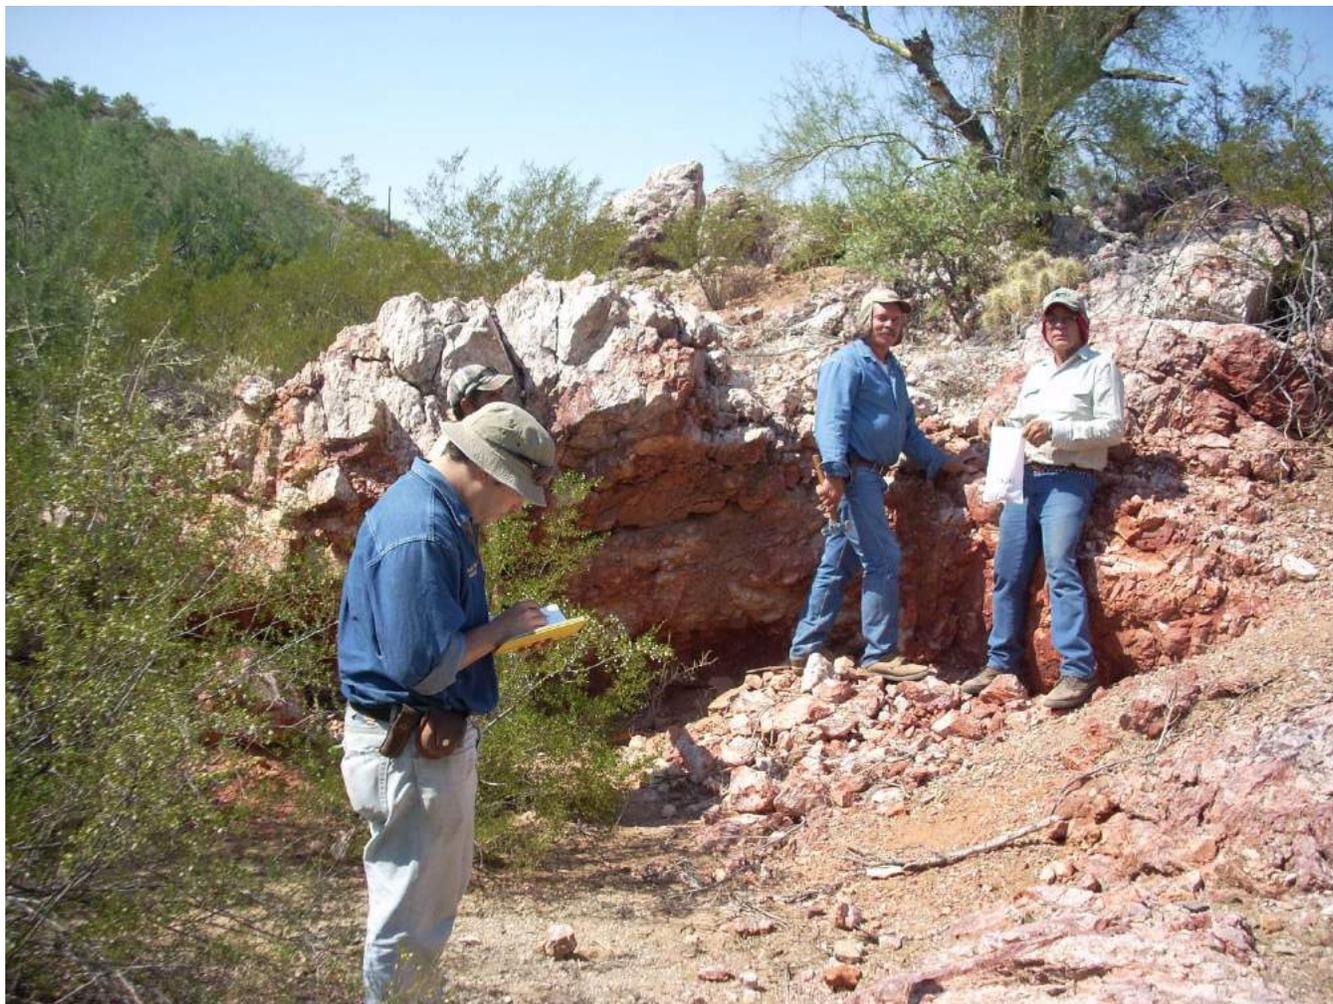
brecciated. **Photo 3** shows a representative exposure. The main quartz vein exposed at a prospect pit is 1.5 m wide and strikes N50W. This vein and two smaller veins (N78W/80SW and N45W/84SW) are oriented sub-parallel to the fault zone exposed at the mine.

Photo 3. View NW at brecciated quartz vein sampled along Cerro Rojo Fault at Waypoint 85 (ELZB 31)

Unfortunately, most rock chip samples collected from the Cerro Rojo fault returned marginal results. At the mine, a channel sample collected across 70 cm of rhyolite breccia within the main fault zone yielded 0.11 ppm Au. A composite sample taken from three limonite shears in the hanging wall rhyolite ran 0.07 ppm Au. A 3-4 cm quartz vein within the main fault zone yielded 0.53 ppm Au. We also collected 5 samples from the brecciated

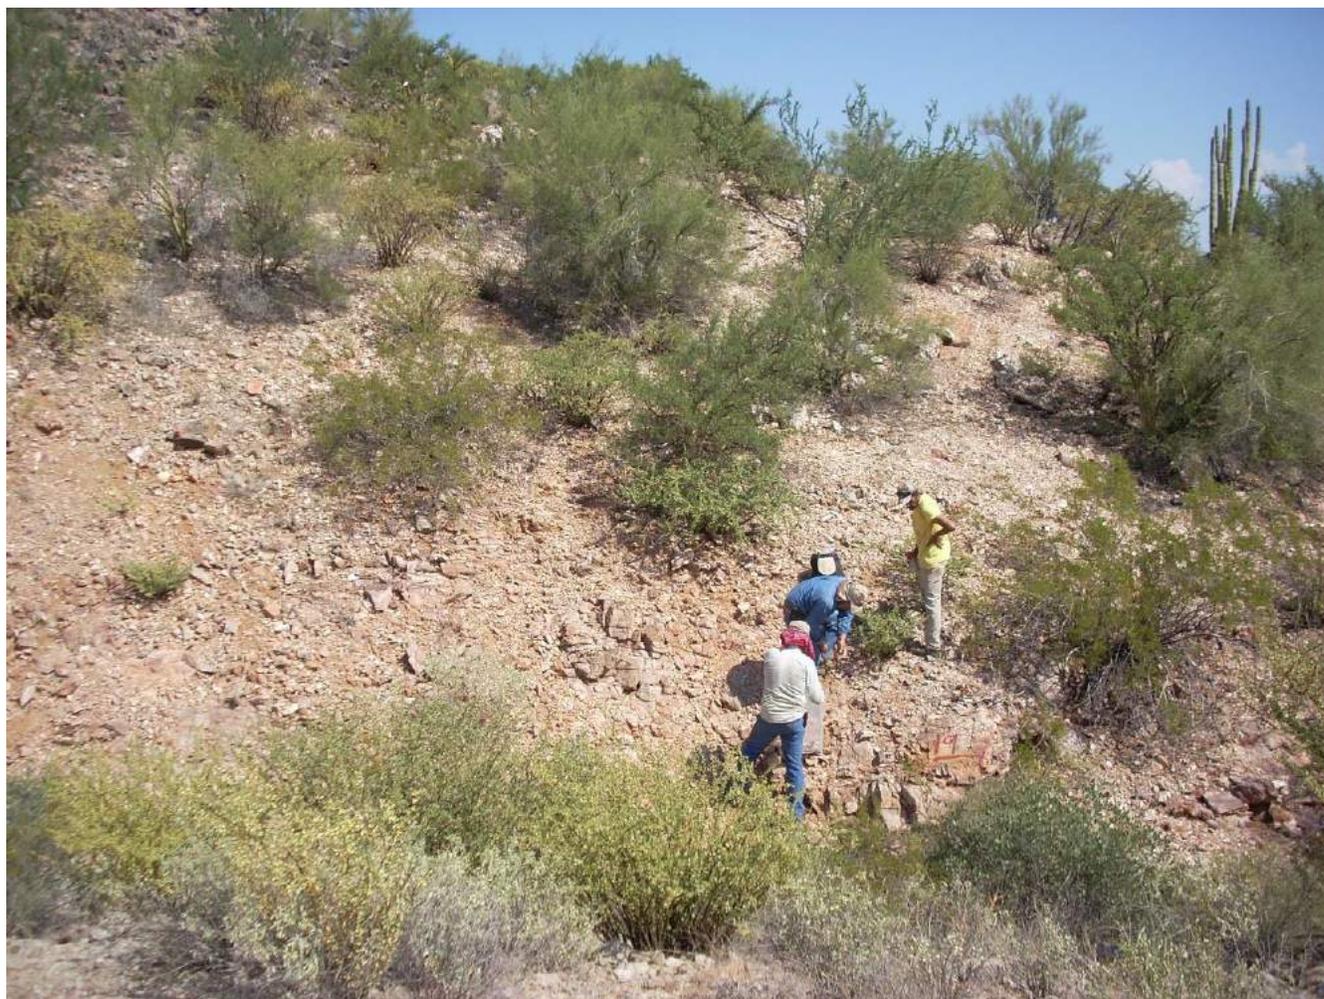
A prominent system of moderately northeast-dipping quartz veins outcrops in the lower east slope of the southeast ridge (**Photo 4**). The largest veins are about 30 cm thick, and appear to alternate with swarms of sub-parallel 1-3 cm thick quartz veinlets. Most of the veins and veinlets display a common orientation (N53-60W/40-47NE), and cut across southwest-dipping foliation in the host rhyolite. The vein system is broken into two parts by a fault (N52W/42 SW) that is locally marked by a resistant red breccia zone.

Photo 4. View northwest toward part of the Quartz Vein Swarm. Rock-chip sample ELZB 19, collected here at Waypoint 71, yielded 0.63 ppm Au.

Due to the relatively low dip of these veins and the promising character of hematite alteration we collected multiple samples in this area. Several of these were channels taken across thin vein networks with hematite-altered rhyolite host. Others were restricted to individual quartz veins or to breccia zones along the NW-striking fault. Eleven rock chip assays returned values between 0.02 and 0.70 ppm Au.

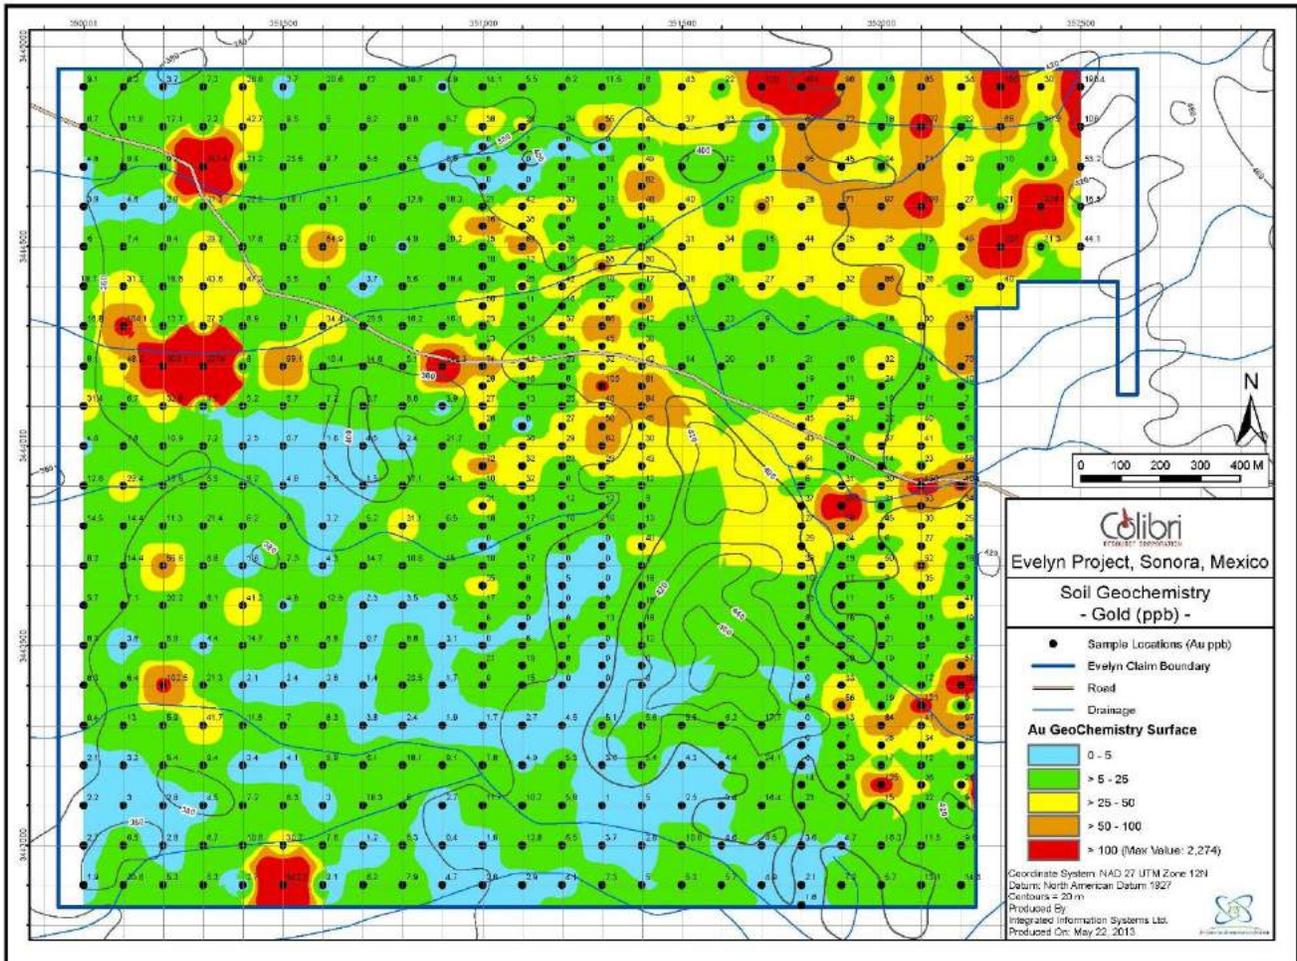
During summer of 2012, Colibri Corporation conducted a geochemical soil sampling endeavor to follow up on the positive results yielded by the rock chip assays. This survey covered most of the claim except for the bedrock ridge in the southeastern part of the claim where the Mine Workings Shear Zone is exposed. Results are shown in **Figure 8**, with gold-in-soil values contoured in **ppb gold**. This map reveals multiple areas with >100 ppb Au that occur in topographically low places not visited during my 2008 reconnaissance mapping. Anomalies indicated in the northeast, west central, and southeast parts of the Evelyn claim deserve future investigation to determine context relative to exposed bedrock or mineralized structures (see discussion associated with **Figure 9** and **Recommendations 1 and 2** below).

Figure 8. Results of 2012 soil geochemical survey. Gold-in-soil values are indicated in ppb Au. Sampling grid did not cover the bedrock ridge with the Mine Workings Shear Zone

The 2012 soil geochemistry survey offers an important guide for future field investigation. Each of the areas encompassing assay values >100 ppb Au warrants detailed geologic mapping and rock-chip sampling. The northeast, northwest, and easterly trends suggested by contours near the gold-in soil anomalies imply a connection to mineralized structures (see also **Figure 9** discussion and **Recommendation 2** below). Likewise, the areas of soil covered by abundant subangular pebbles and cobbles of quartz float likely represent places where vein quartz has weathered out of underlying subcrop. Several of these places have been exploited by clandestine placer operations. Given that vein quartz is

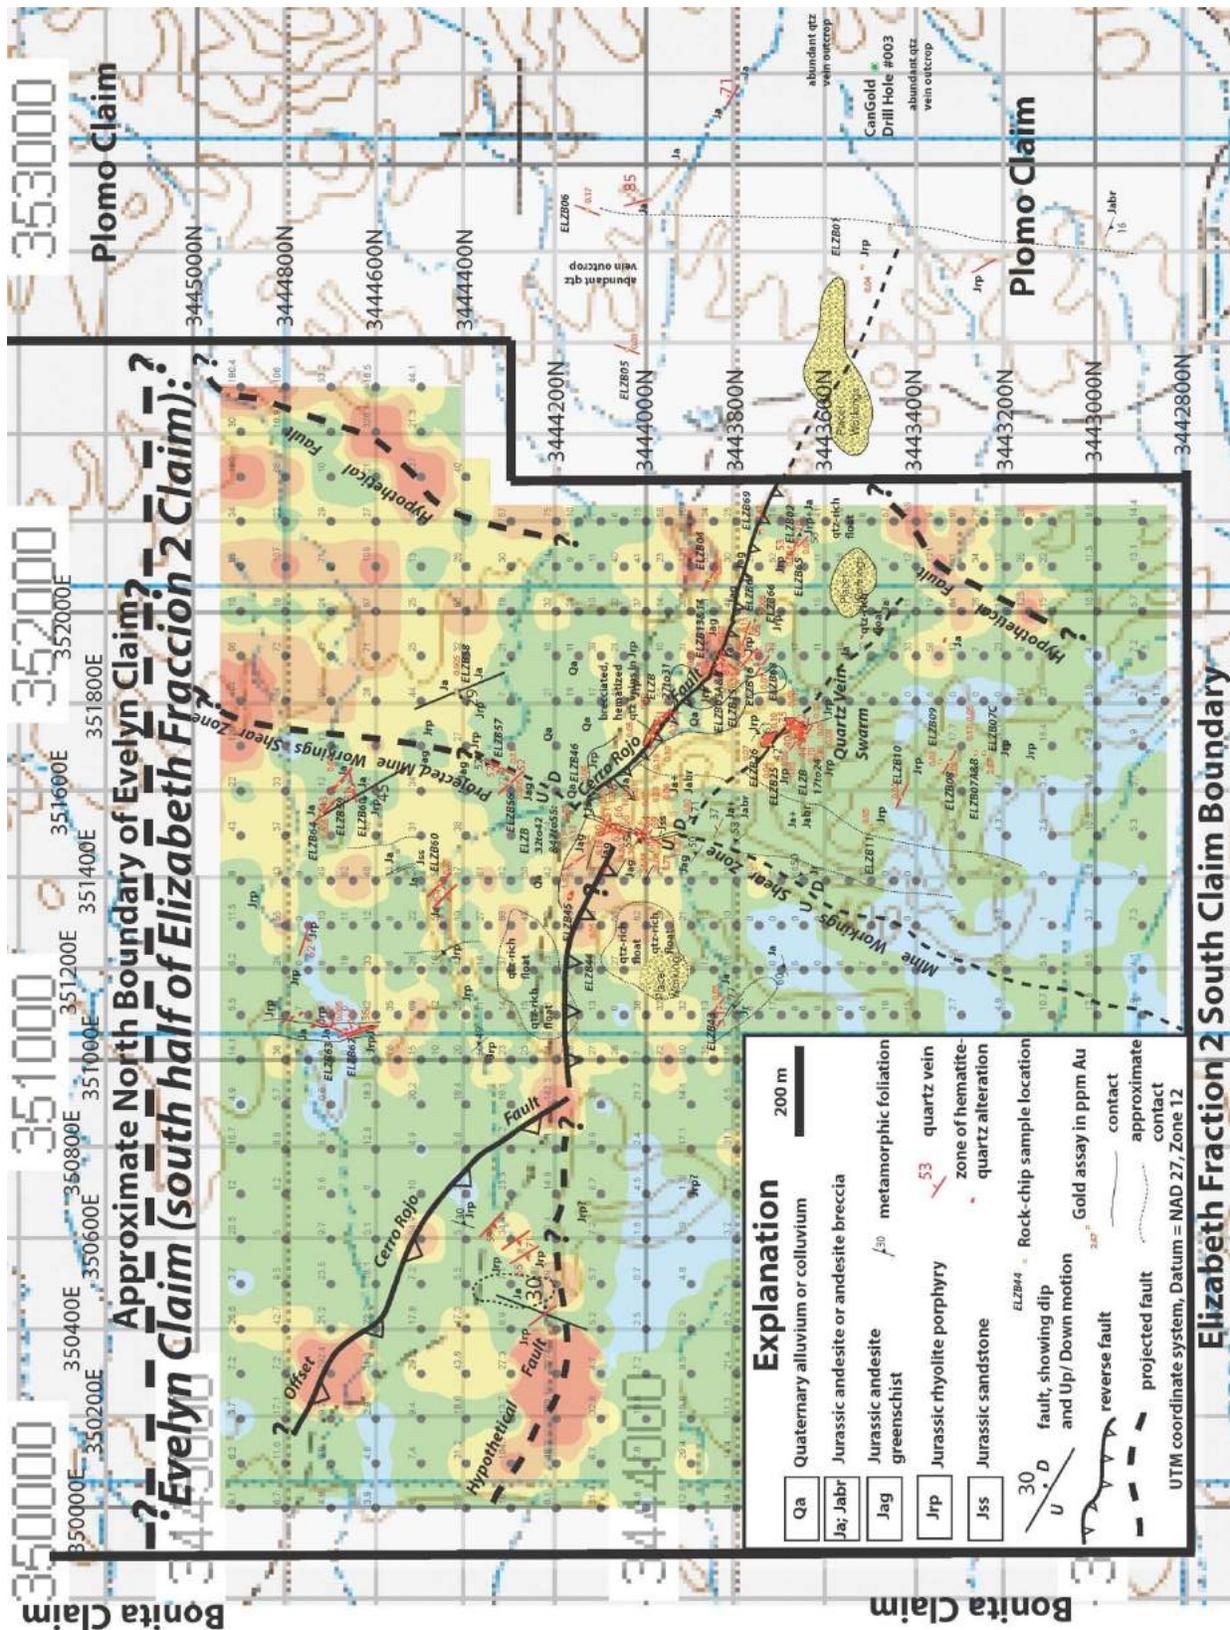
Figure 9 is a composite view of my geologic-structural map, rock-chip gold assays, and contoured gold-in-soil values. As shown previously in **Figures 6, 7, and 8**, rock chip gold assays are indicated in **ppm Au**; values of gold-in-soil are indicated in **ppb Au**. Perhaps the most striking thing about this map is the tendency of the surface gold anomalies to follow northeast, northwest, or easterly trends. Depending on how the Mine Workings Shear Zone and Cerro Rojo Fault interact, it is possible that certain anomalies represent projections of these structures.

Figure 9. Composite map showing overlay of geology-structure, rock chip assays and soil geochemistry figures presented earlier. Also shown are hypothetical projections of known faults and other likely mineralized structures (see discussion in text).

I present one possible structural interpretation of this data set in **Figure 9**. The northeast-striking Mine Workings Shear Zone is interpreted as a normal fault (northwest side up) that offsets the northwest-trending Cerro Rojo Fault. In this perspective, the northeast projection of the Mine Workings shear zone intersects one set of gold-in-soil anomalies (404 ppb and 120 ppb Au) at the north edge of the property, while a buried, displaced Cerro Rojo reverse fault may coincide with a string of three soil anomalies (792 ppb, 65 ppb, and 142 ppb Au, respectively) that occur along a N45W line.

Left for speculation are two additional linear gold-in-soil anomalies in unmapped areas. At the northeast corner of the Evelyn property, four soil samples that returned 237 ppb, 326 ppb, 106 ppb, and 190 ppb Au occur on a N15-20E line very similar to the strike of the Mine Workings Shear Zone. Near the west central part of the property, a string of 5 soil anomalies, (including assay values of 2274 ppb and 303 ppb Au) follows an easterly trend. Also worth speculation is the fact that two main structures exploited by Noche Buena Mine follow similar easterly trends.
